# **Little Penguin Management Report for storm drain works in Central Coast Council**

Dr Perviz Marker  
September 2024  
Updated February 2025

This document provides a survey and report on the presence of Little Penguins at proposed storm drain locations as requested by Central Coast Council.

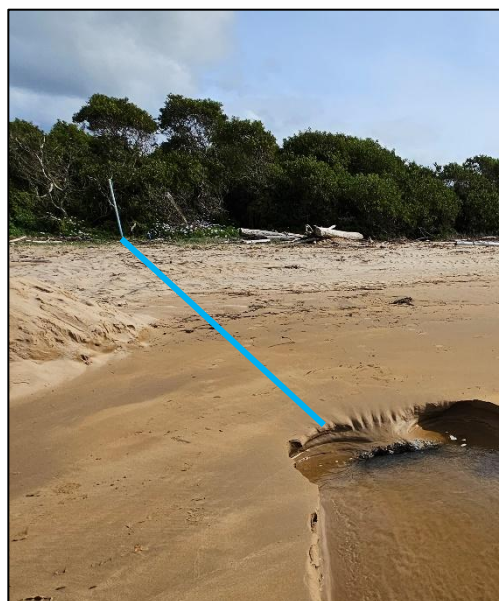
**Figure 4:** Looking inland from the old storm drain that will be replaced to the blue pole that shows the start of the proposed works.

Penguins transit to their colony located behind the works zone in the vegetation (Figure 3) crossing the beach (Figure 4), after dark or before dawn. Fewer than 5 penguin tracks were observed in the sand within a 2m corridor on either side of the proposed drain works on the beach. A few more tracks were observed from the survey carried out in January 2025. In particular penguin tracks were observed at a distance of up to 10m between the vehicle access track and the storm drain work site. These surveys indicate that the area is an active penguin zone.

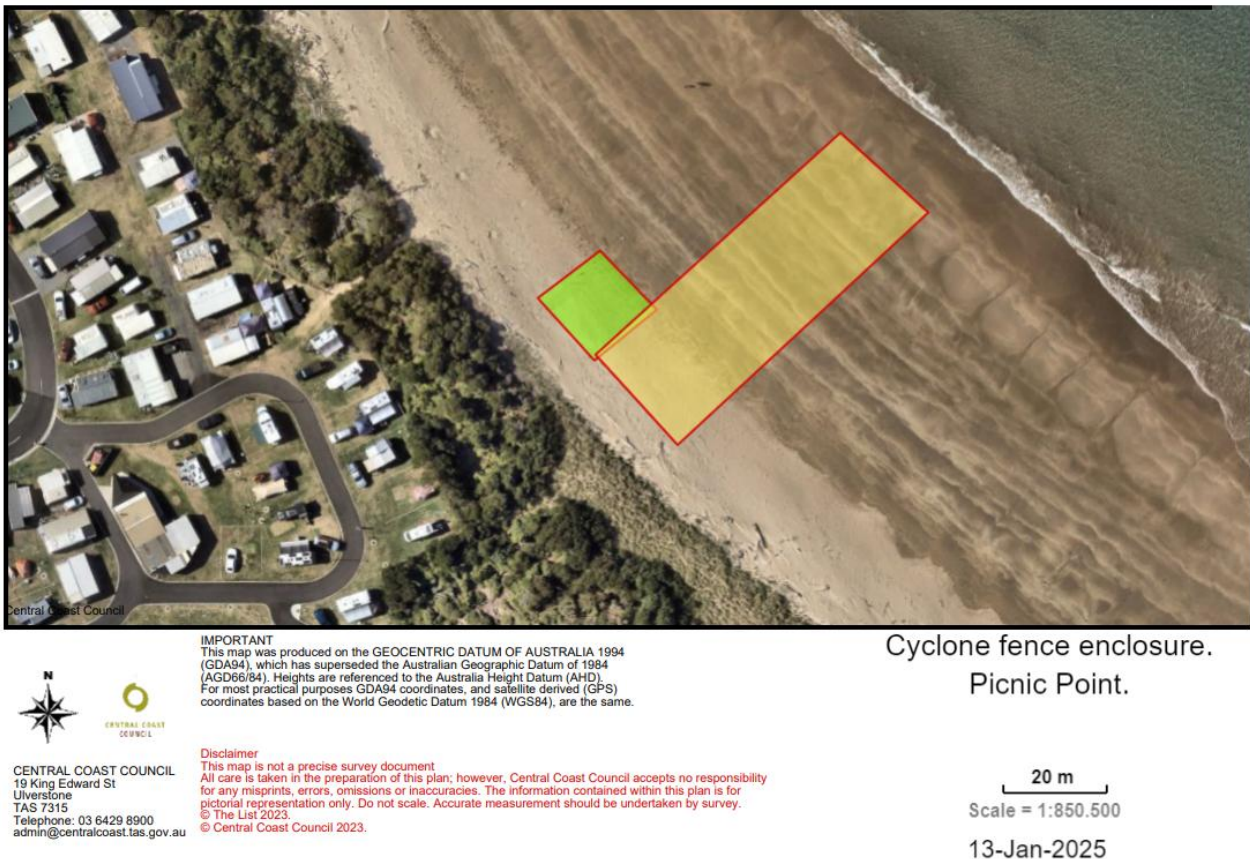
**Figure 5:** Map provided by CCC showing the cyclone fence enclosures; a 10m x 10m storage compound for any materials to be used daily, an 8m area either side of the pipeline to the water line (yellow). The enclosures are not drawn to scale

- The work storage area 10m x 10m, (green in Figure 5) indicates where materials will be stored, and a corridor of 8m on either side of the storm drain (yellow in Figure 5) shows the footprint of the storm drain.
- Once work is completed for the day and machinery is returned to the car park area, then the beach area will need to be fenced off with chicken wire fencing to prevent access to any part of the work zone by penguins.
- Chicken HD wire (cyclone HD netting with 4cm mesh) is to be used, as this prevents penguins getting caught in the wire compared to the light more flexible wire. The barrier mesh should be wide enough to allow approximately 100mm to be dug into the sand, or bent outwards and fixed in the ground with tent pegs or steel star pickets (or similar) to prevent penguins burrowing under the barrier, and

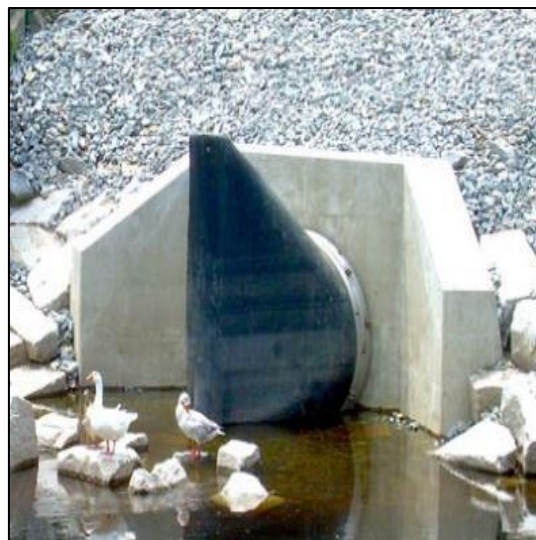
**Figure 7:** Duck bill flap over storm drain

It is recommended that the storm drain will need a duck bill flap (Figure 7) fitted to the end of the drain to avoid penguins accessing the interior of the drains.
